HOME INSPECTION REPORT

Sample Report

1234 Davis St, Raleigh, NC 27608

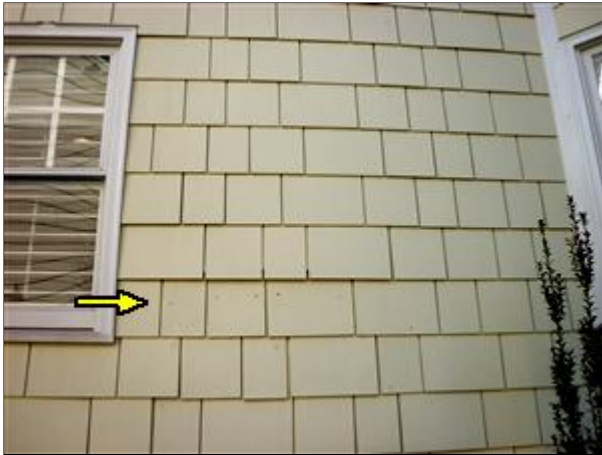
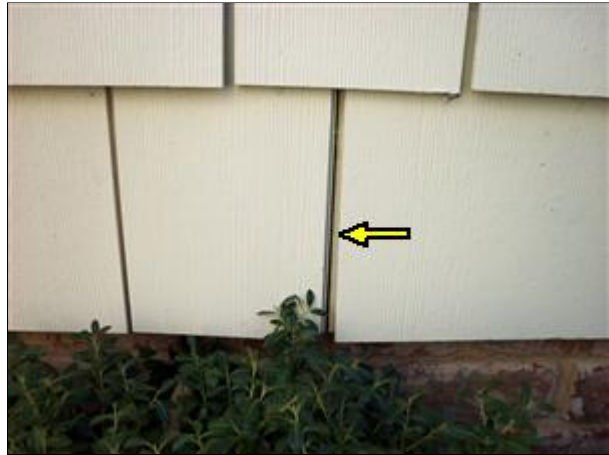
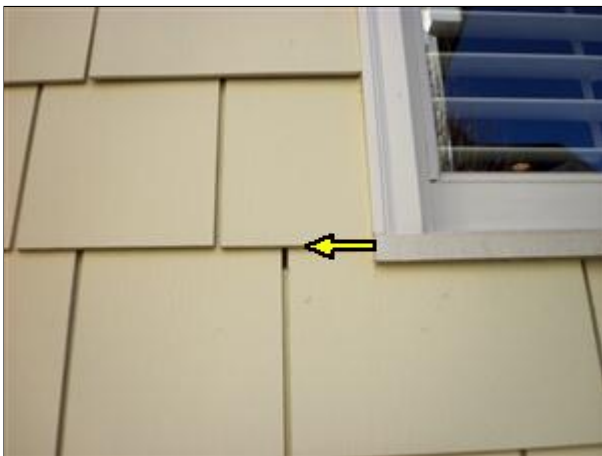
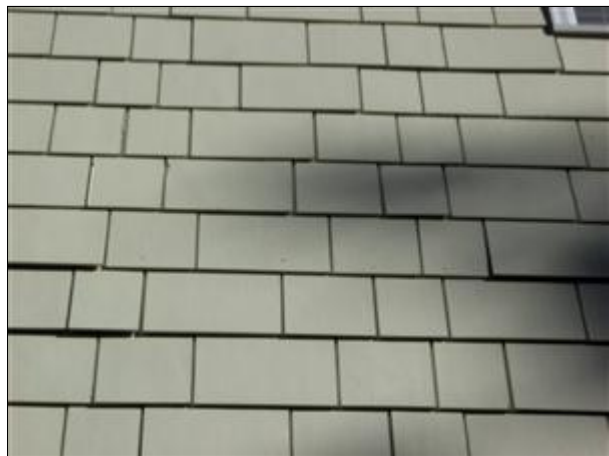
2.0 Picture 1

🏠 (1) There is a large area of siding on the right side at the kitchen window where the siding is wavy and loose on the wall. Several shingles have been face nailed with improper nails that are rusting. The house wrap is visible in some areas where the shingles do not properly overlap which can possibly allow water entry into the wall cavity. Another similar area was observed on the left side at the second floor level above the main electrical panel. I recommend a siding professional investigate all of the siding on the home to determine if it was installed according to the manufacturers specifications and to make any needed repairs.

2.0 Picture 2 improperly aligned joints

2.0 Picture 3 visible house wrap

2.0 Picture 4 Left side above electrical panel

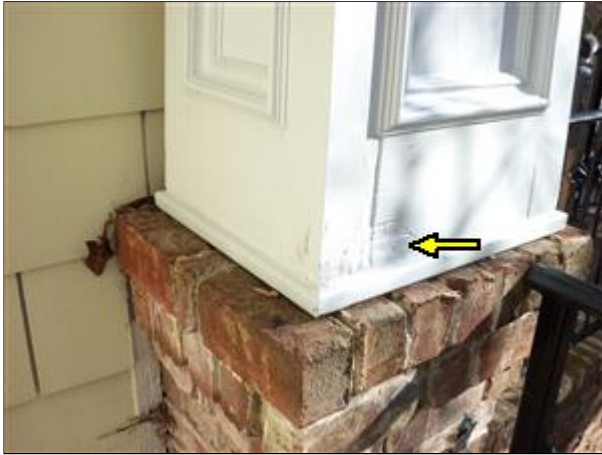
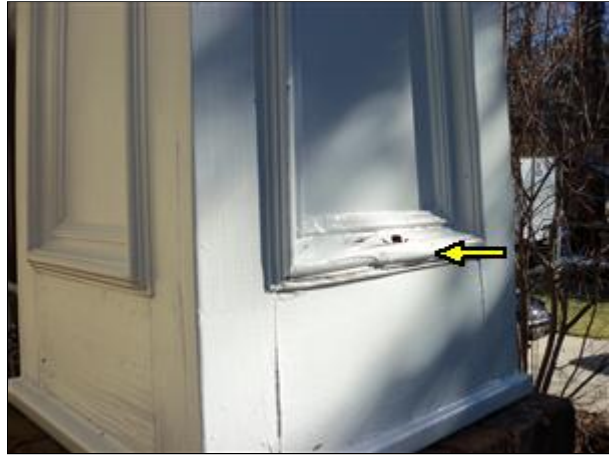
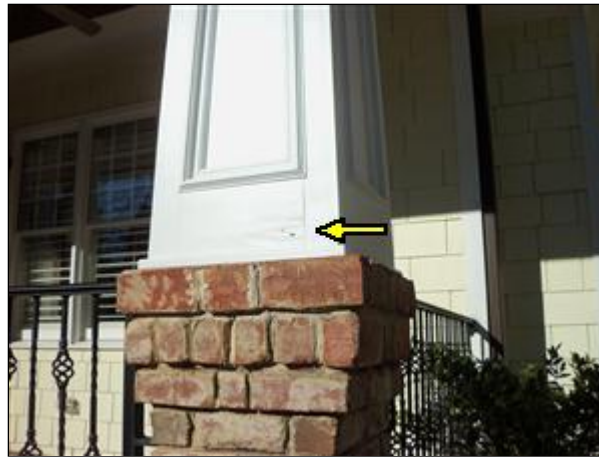
2.0 Picture 5 Office

🏠 (2) The two front columns at the office and the far right front porch column have deterioration present in the lower ends and needs repairs or replacements. The columns may be load bearing and should be repaired by a licensed general contractor.

2.0 Picture 6 Office

2.0 Picture 7 Front right

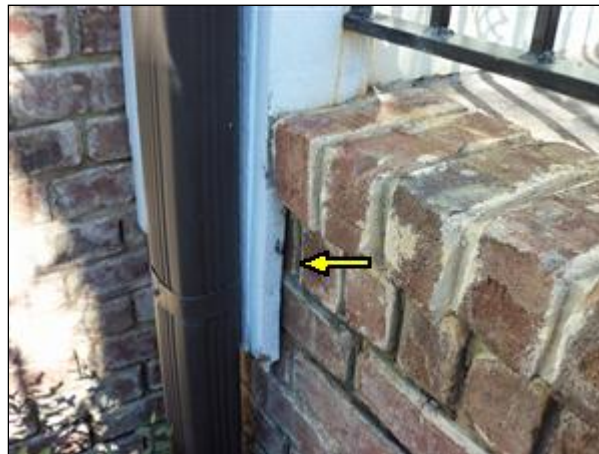
2.0 Picture 8

🏠 (3) There is deteriorated trim at the far left of the front entry below the iron railing that needs replacement and painting.

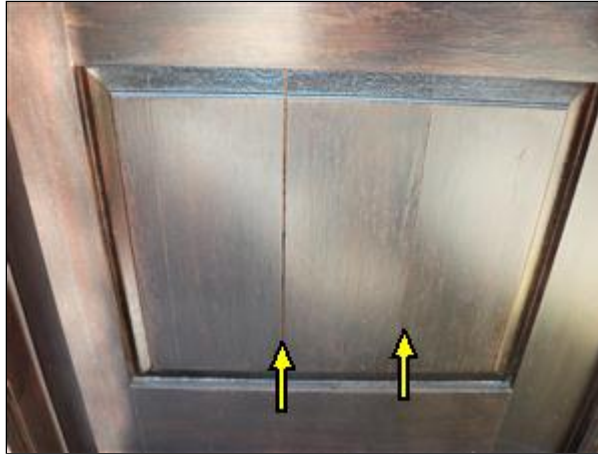
2.1 Picture 1

- 🏠 (1) The exterior of both front entry door panels are gapped open and needs repairs. The gaps are not present though to the interior and this may be considered cosmetic. I recommend repairs as needed by an appropriate specialist.

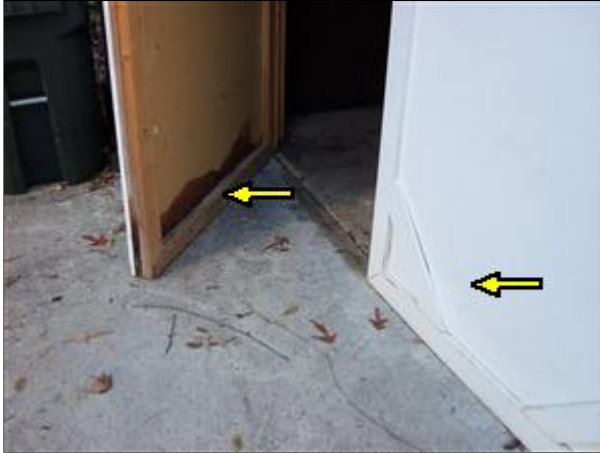
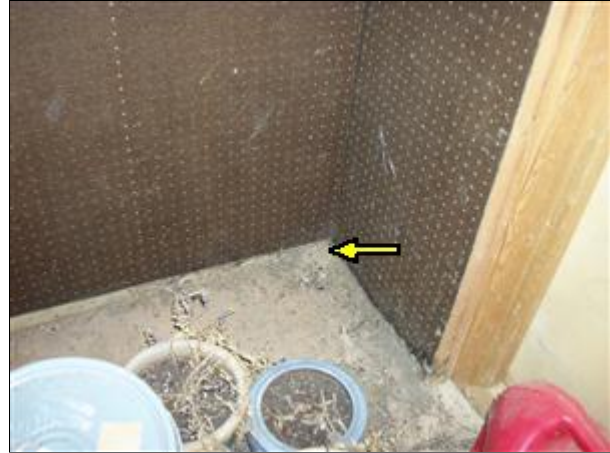
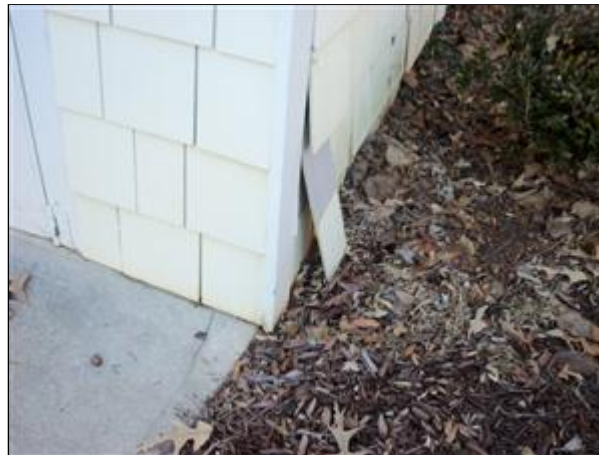
2.3 Picture 1

The storage shed doors are deteriorated and there are termite tubes present at the inside corners. The building is at ground level which is conducive to deterioration and insect damage (as has already occurred) I recommend further investigation to determine if the termites are active by a pest control specialist, and repairs throughout as needed by a qualified contractor.

2.3 Picture 2 termite tubes

2.3 Picture 3 damage at corner - at ground level

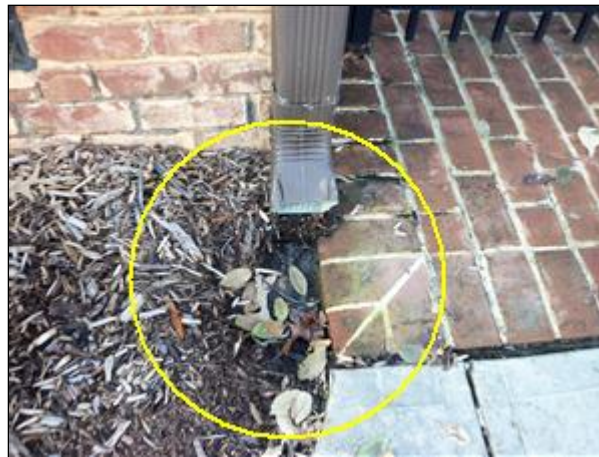
3.1 Picture 1

The downspout at the left rear corner is causing erosion at the corner of the driveway and walkway. The downspout needs to be extended out or have splash block added to prevent continued erosion.

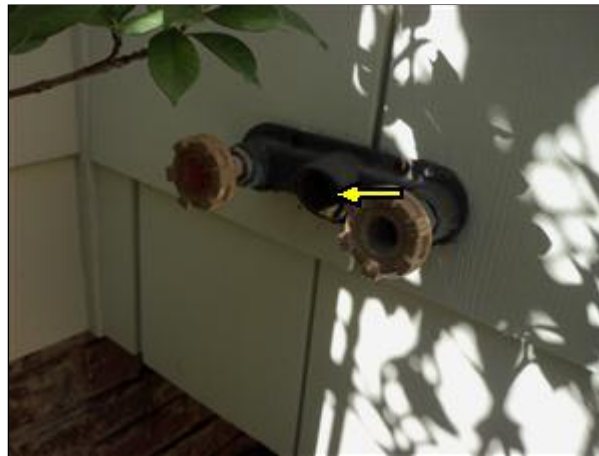
4.0 Picture 1

(1) The hose connection at the right of the entry is damaged and needs repairs or replacement.

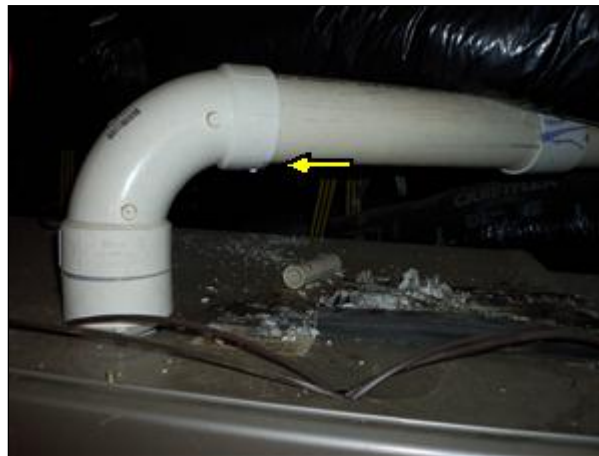
6.2 Picture 1

The crawlspace furnace vent is dripping condensation onto the top of the air handler and needs repairs by an HVAC contractor.

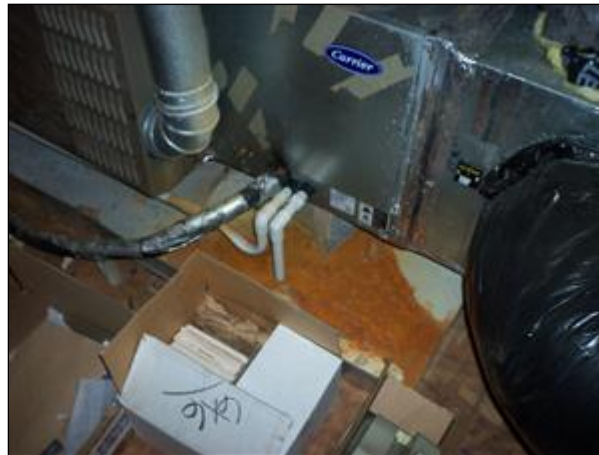
7.0 Picture 1

(1) There is rust in the condensate overflow pan at the air handler in the attic. This is a common item found in many homes and may have been repaired in the past. I recommend obtaining service records from the current owner to verify repair or having the unit serviced by a licensed HVAC contractor.

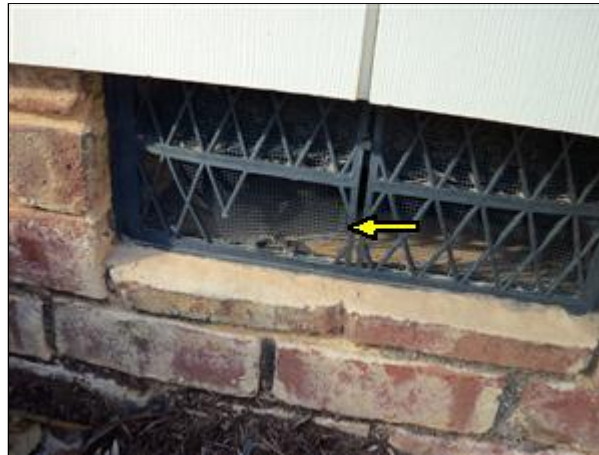
9.3 Picture 1

The foundation vent at the right rear corner is damaged and needs repairs to prevent pests from entering.
